Technical Preservation Services
Preservation Assistance Division
National Park Service
U.S. Department of the Interior
Washington, D.C.

Interpreting the Secretary of the Interior's Standards for Rehabilitation

Volume III

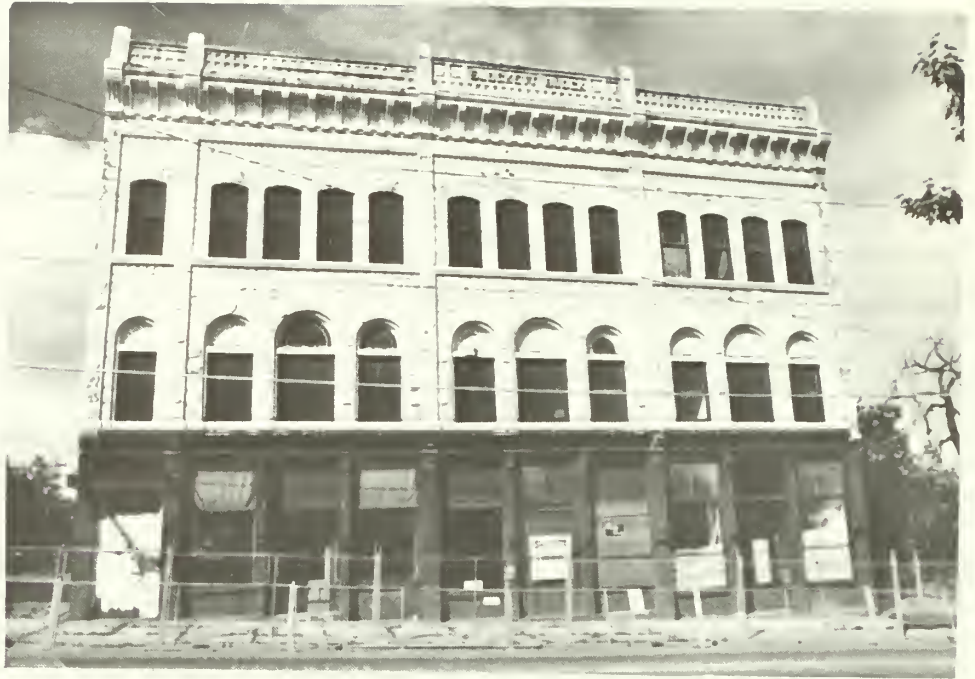
1. 1890 commercial building prior to rehabilitation.

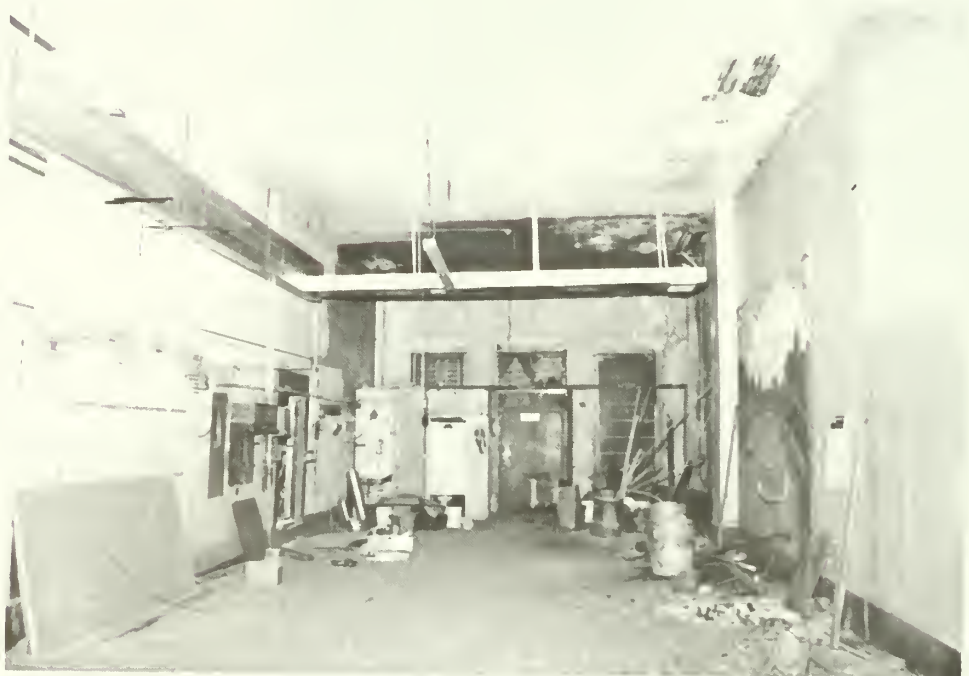
2. Typical ground floor space before rehabilitation.

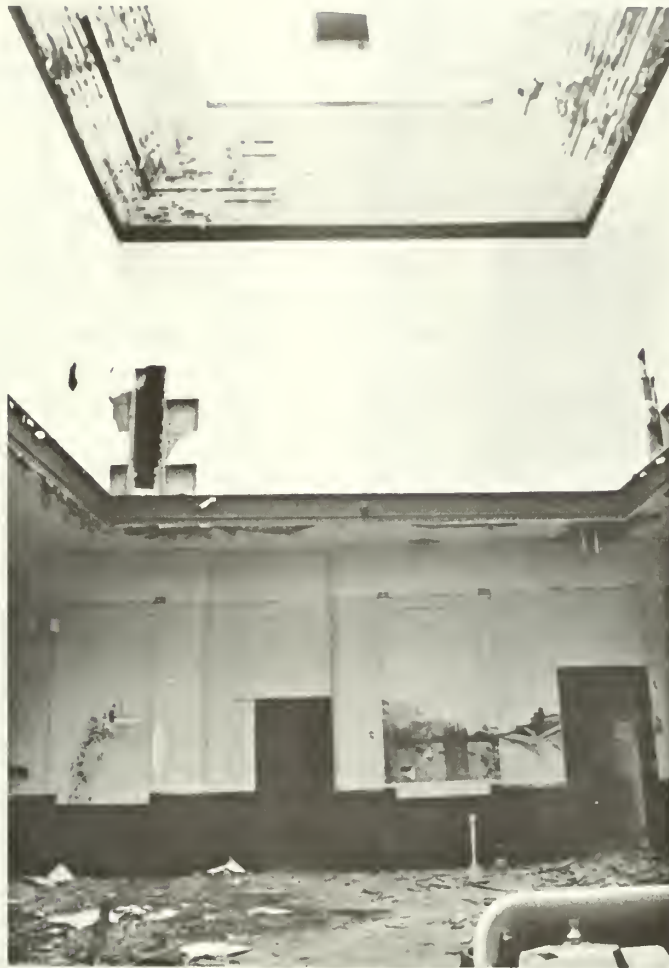
3. View of central space showing atrium extending through the second and third floors, with skylight above. The second floor doors shown lead to rooms beyond. Windows have been blocked in, but their configuration is still apparent from the surrounding trim. On the third floor the open hallway had been partitioned.

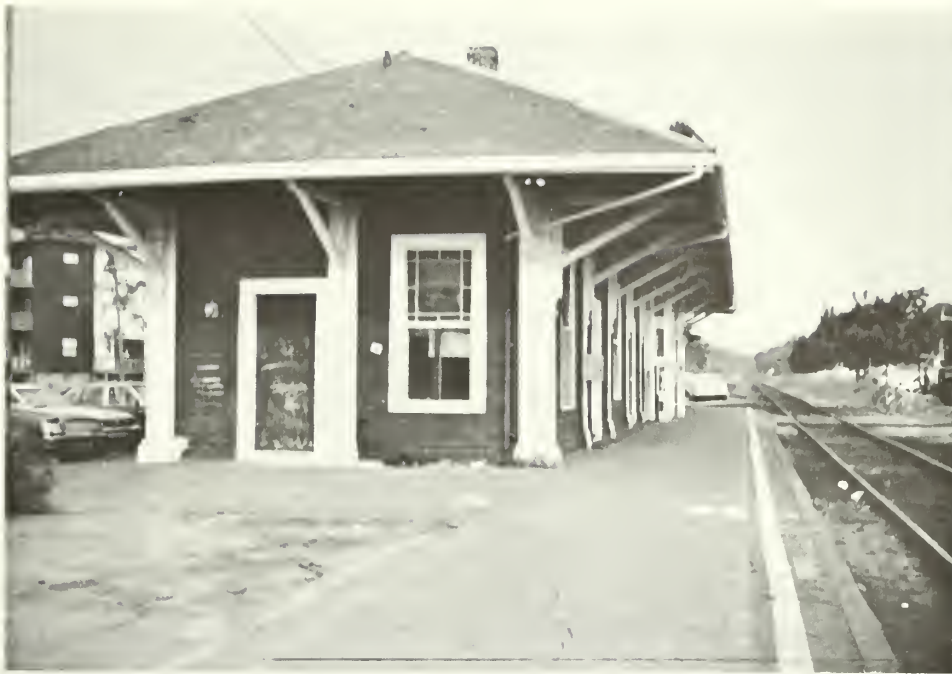
The majority of the project work on the building's exterior, including window and roof repair, was sensitively accomplished; one exception was the construction of an awkward-looking exterior ramp and fence at the south end. Work on the interior however, involved incompatible alterations to accommodate seating for the restaurant. The ticket booth, a distinctive element that contributed to the definition of the historic function of this train station, was removed and the original ticket window relocated (see illus. 4). Approximately two-thirds of the plank ceiling and cornice, features characteristic of the Stick style, were also removed (see illus. 5), to permit full utilization of the second floor. The Secretary of the Interior's Standards for Rehabilitation require that distinctive features which characterize a building, structure, or site be treated with sensitivity. They also require that the removal or alteration of any historic material or distinctive architectural features be avoided when possible. The removal of these intact features and insertion of new architectural elements greatly impairs the historic character of the structure and violates the Standards.

1. Railroad depot prior to rehabilitation.

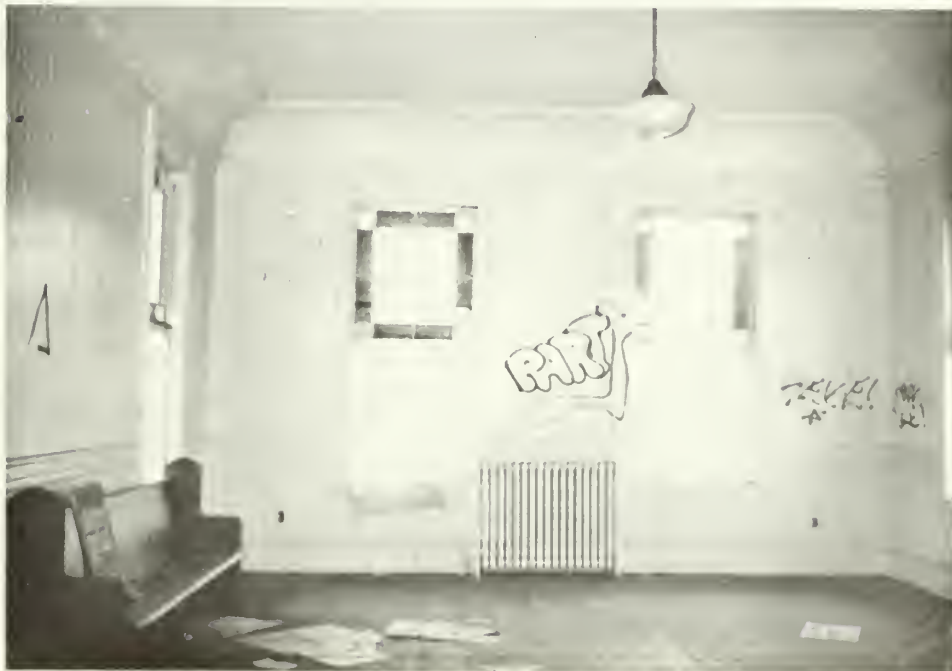
2. Interior view of waiting room prior to rehabilitation. Note wooden ceiling and wide coved cornice.

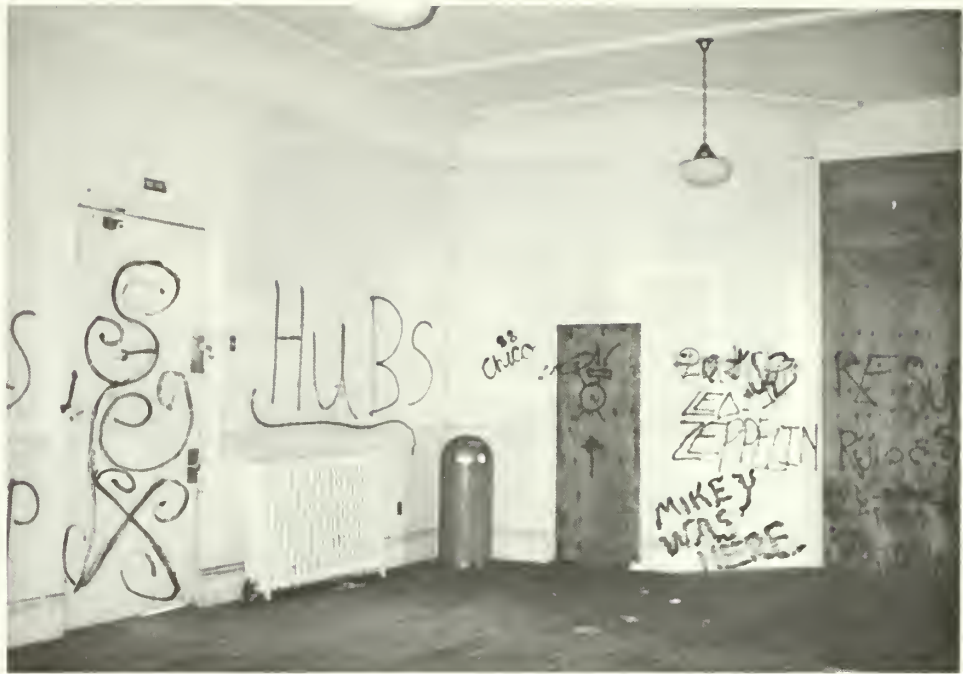
3. Interior view of ticket booth prior to rehabilitation. This historic feature was removed in the process of rehabilitation.

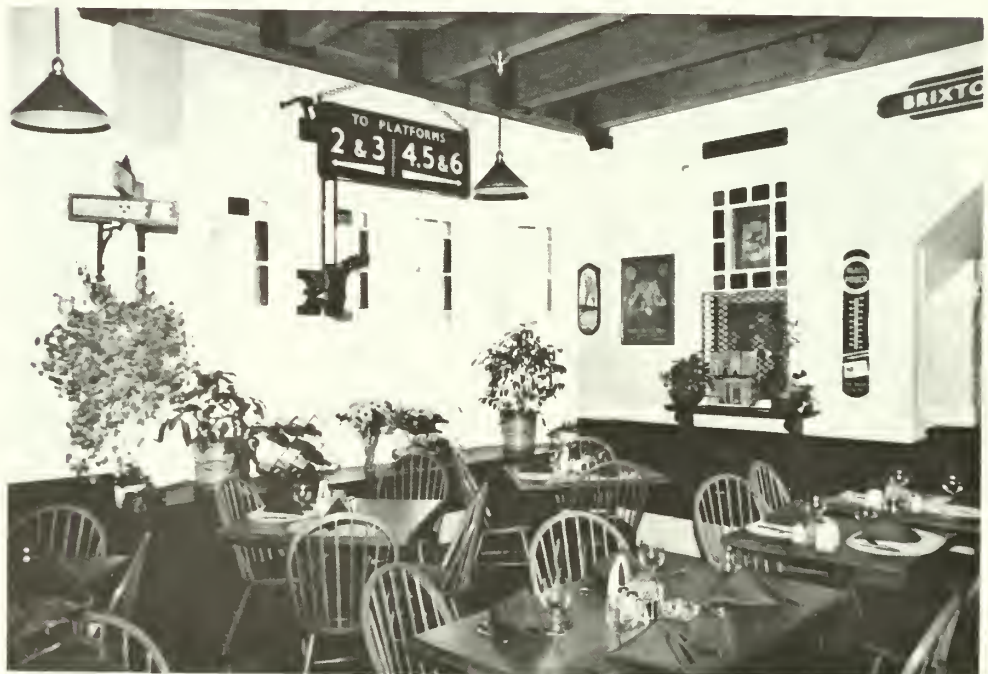
4. Post-rehabilitation view of waiting room after the removal of ticket booth. Note ticket booth window relocated in new stair wall.

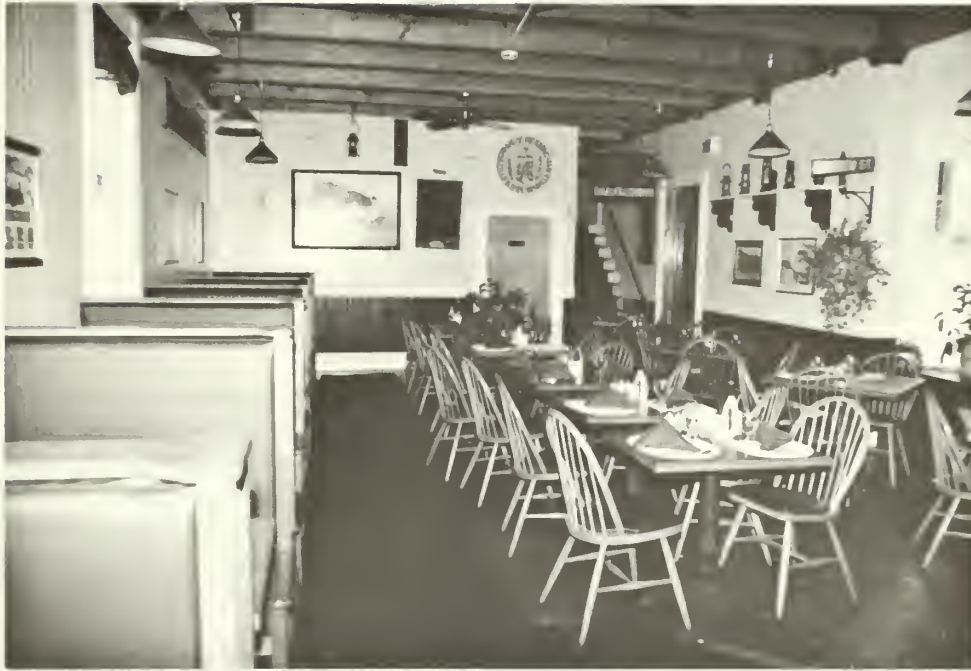
The ceiling of the depot which was removed to install a functional second floor above, was replaced with new ceiling joists dropped below the original first floor ceiling (see illus. 5 & 6). The new unfinished and exposed wood joists are not in keeping with the character of the previously finished waiting room. Further compromising the room was the insertion of restrooms and a staircase at one end of the waiting room; two end windows were obliterated and the distinctive waiting room was reduced by approximately 1/4 to 1/3. Although some detailing was retained on the interior, it was extensively reconfigured, and the new features added were incompatible to the building. As a result, the existing 19th century interior lost its integrity and historic character.

5. Post-rehabilitation view of waiting room. Note the removal of existing ceiling, and the addition of exposed ceiling joists above.

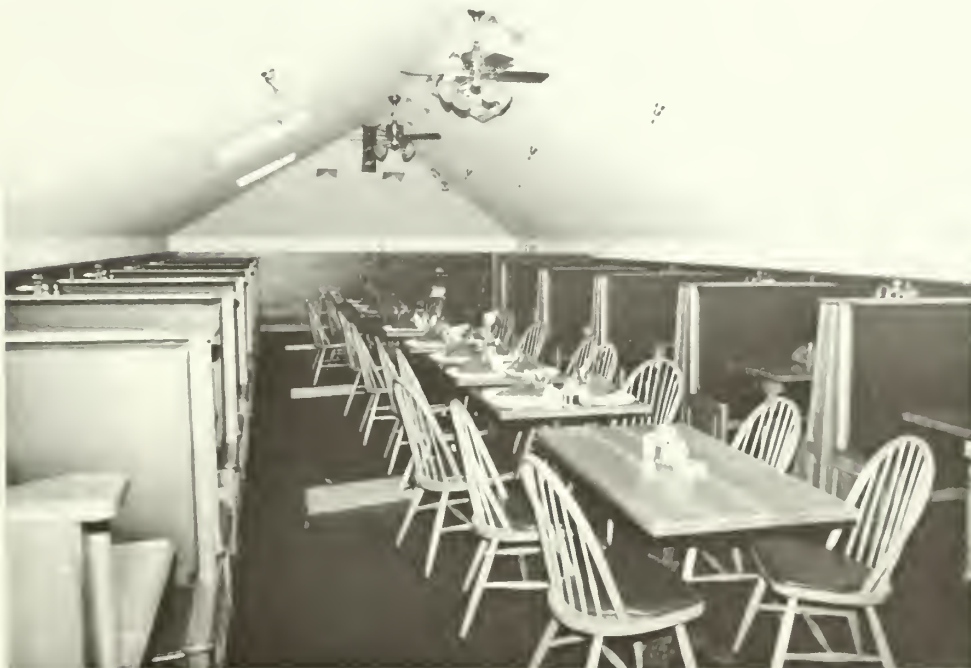
6. Post-rehabilitation view of second floor. Original attic space converted to restaurant space by lowering the ceiling below.

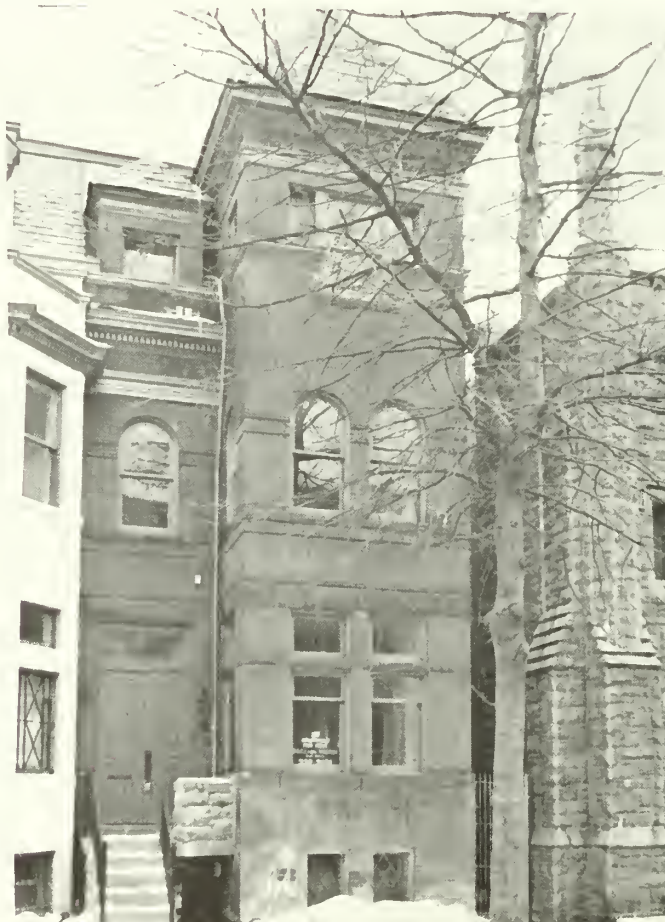
1. The exterior of this 1893 brick rowhouse is its primary character-defining feature through which it contributes to the historic district.

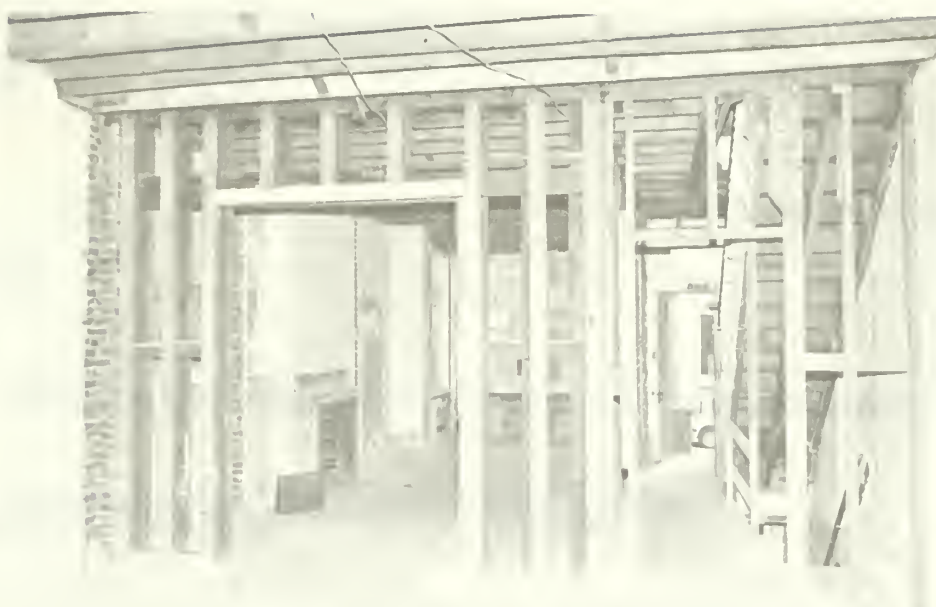
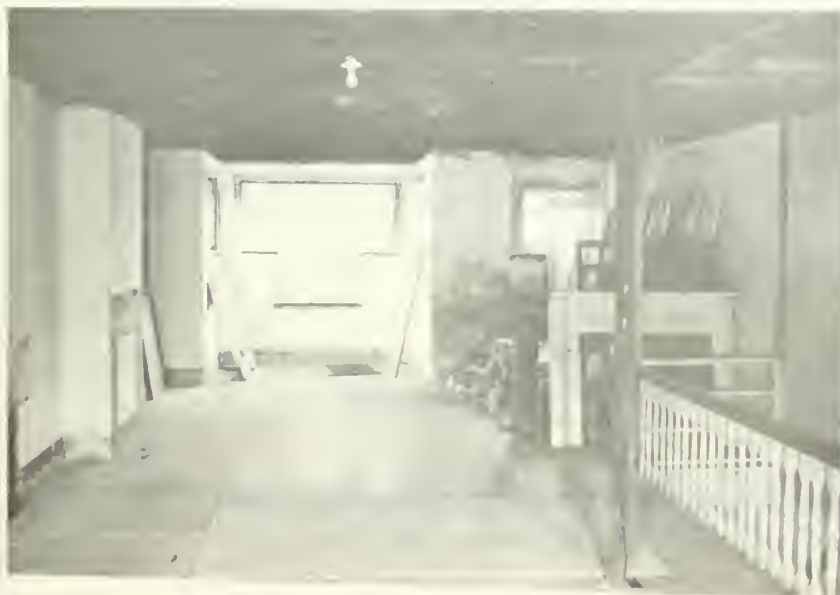
Despite the existing shell-like condition of most of the interior, the new owner restored the historic staircase (although code compliance necessitated several changes) and repaired and reused the woodwork and trim that had been removed by the previous owner. Because the rehabilitation also included a careful restoration of the exterior, which was the major remaining character-defining aspect of the building through which it contributed to the significance of the historic district, the rehabilitation was certified.

2. The interior of the house after it had been "gutted" by the previous owner. The photographs of all 3 floors are taken from the same location on each floor, and show views toward the front of the house. The new owner was able to repair and reuse wood trim (here, shown piled behind the stairs on the third floor), that had been removed by the previous owner.

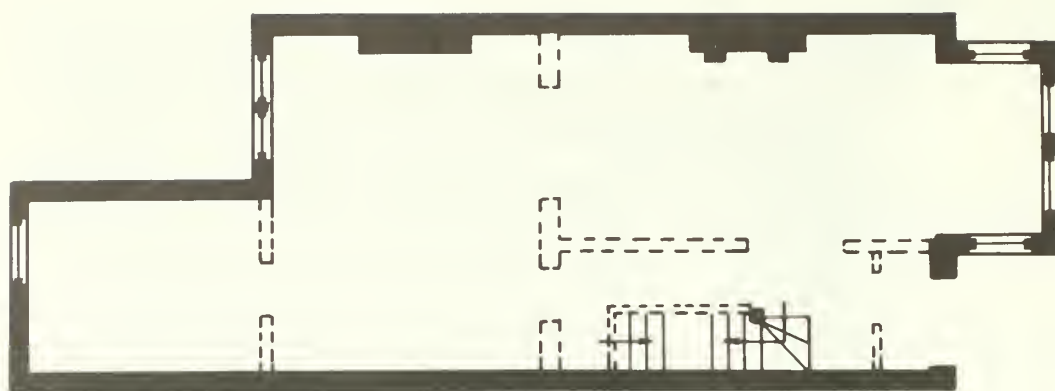
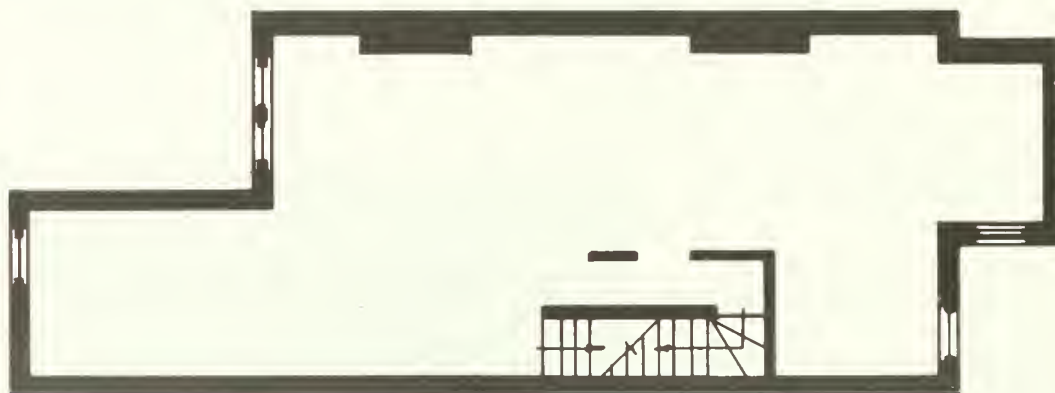
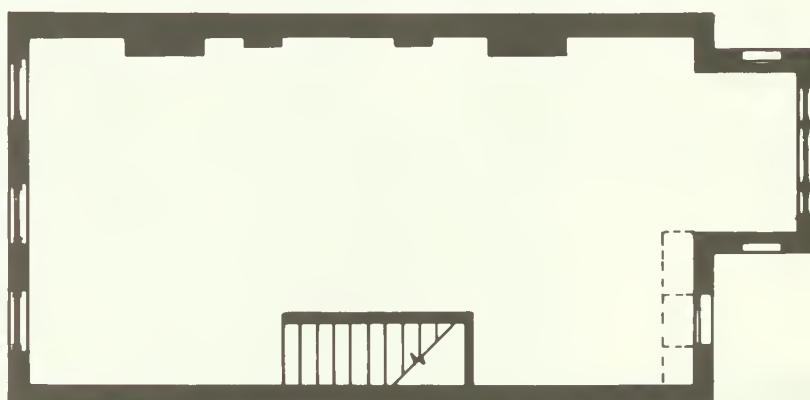
3. Floor plans of the interior prior to rehabilitation. The fireplaces had been removed during previous renovations. Dashed lines represent open stud walls.

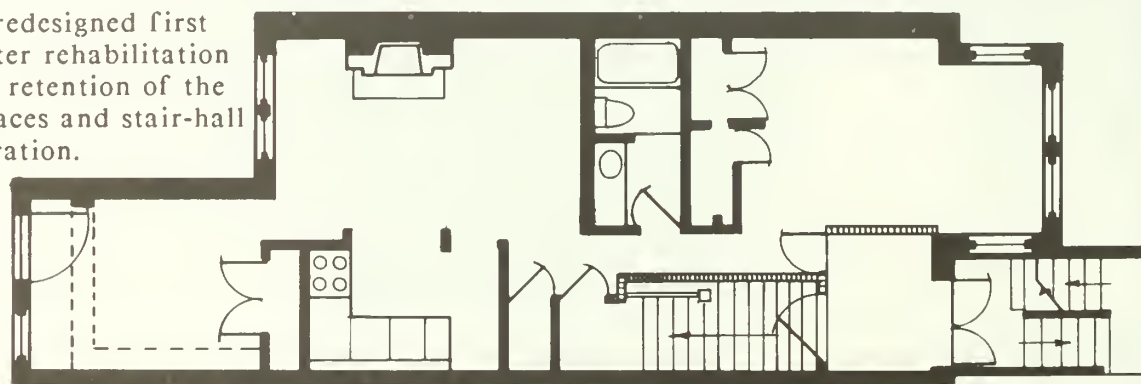
FIRST FLOOR REHABILITATION

generally not a recommended rehabilitation treatment, **in this case** it was minimally acceptable because it did not destroy an original or historic spatial sequence. That had already been lost when the previous owner removed the walls which had traditionally defined these spaces.

4. The redesigned first floor after rehabilitation showing retention of the basic spaces and stair-hall configuration.

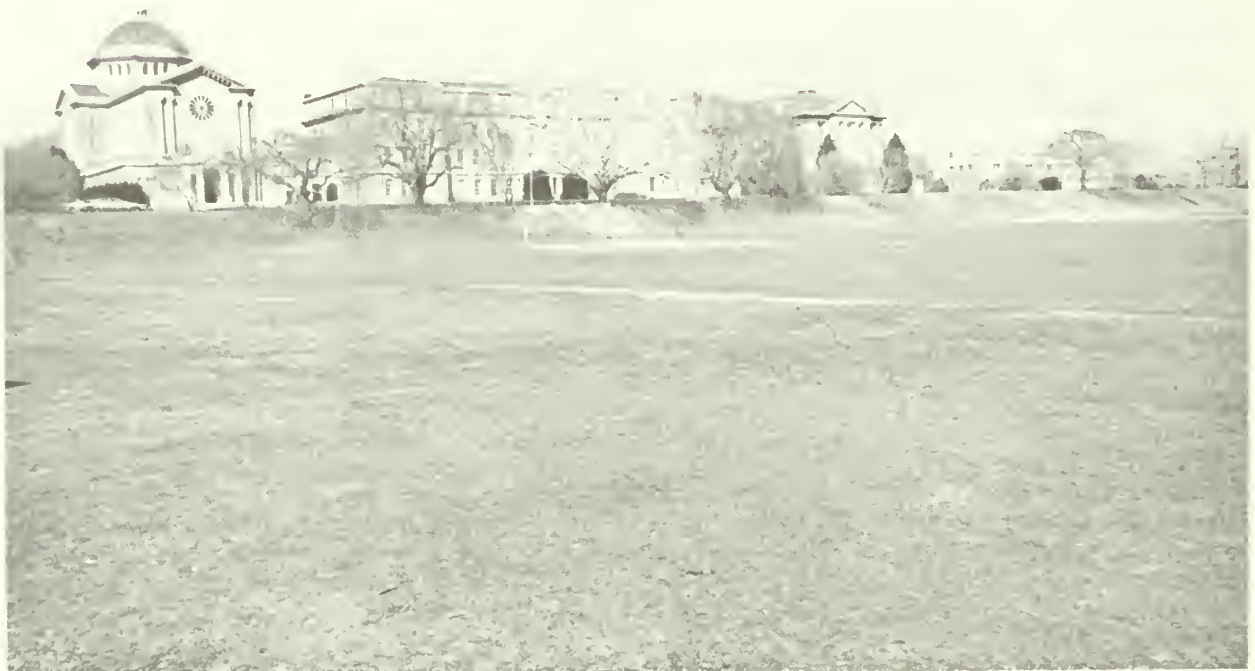
Although the new construction is generally sympathetic to the neighboring historic buildings in size, scale, color, materials, and design, it fails to meet Standards 2 and 9 of the Standards for Rehabilitation because of its impact on the site and environment of the building it obscures.

1. The alignment of the principal structures overlooking a formal terrace, expansive lawns and playing fields was a principal feature of the historic campus.

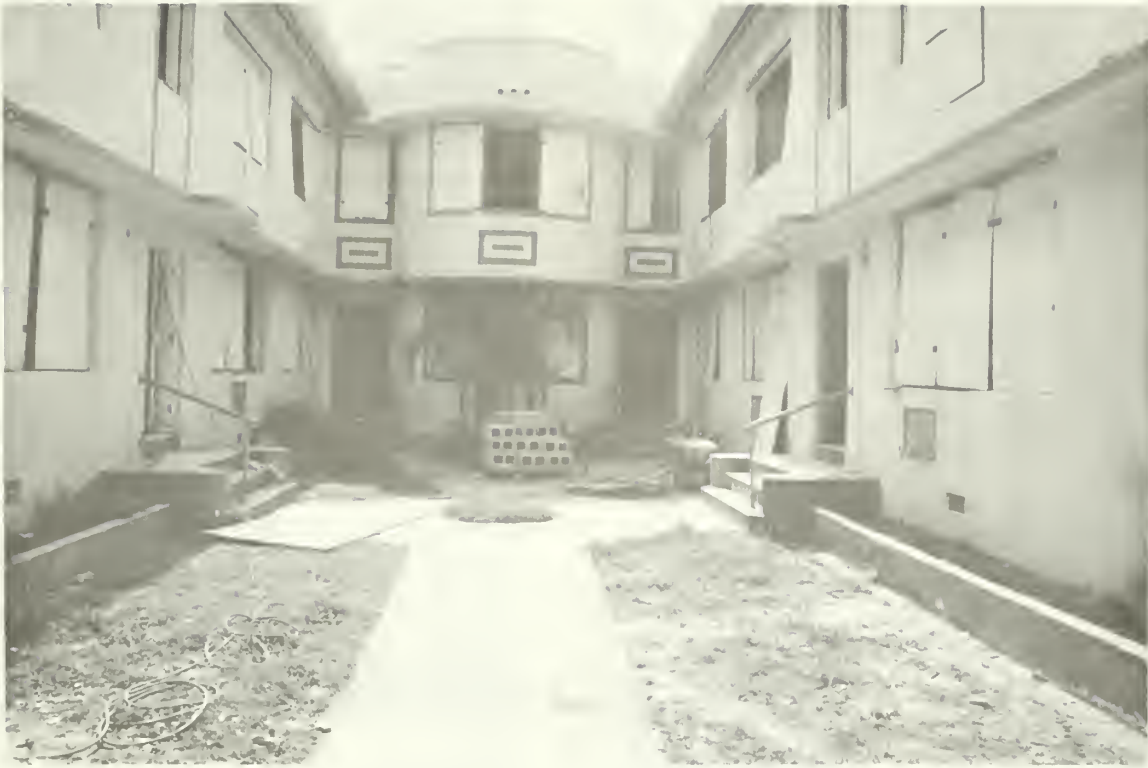
1. The primary entrances to this early 1940s Moderne apartment building are located in the courtyard of the U-shaped structure. Note the overall plainness of the building before rehabilitation, which is highlighted only by horizontal banding and raised geometric panels.

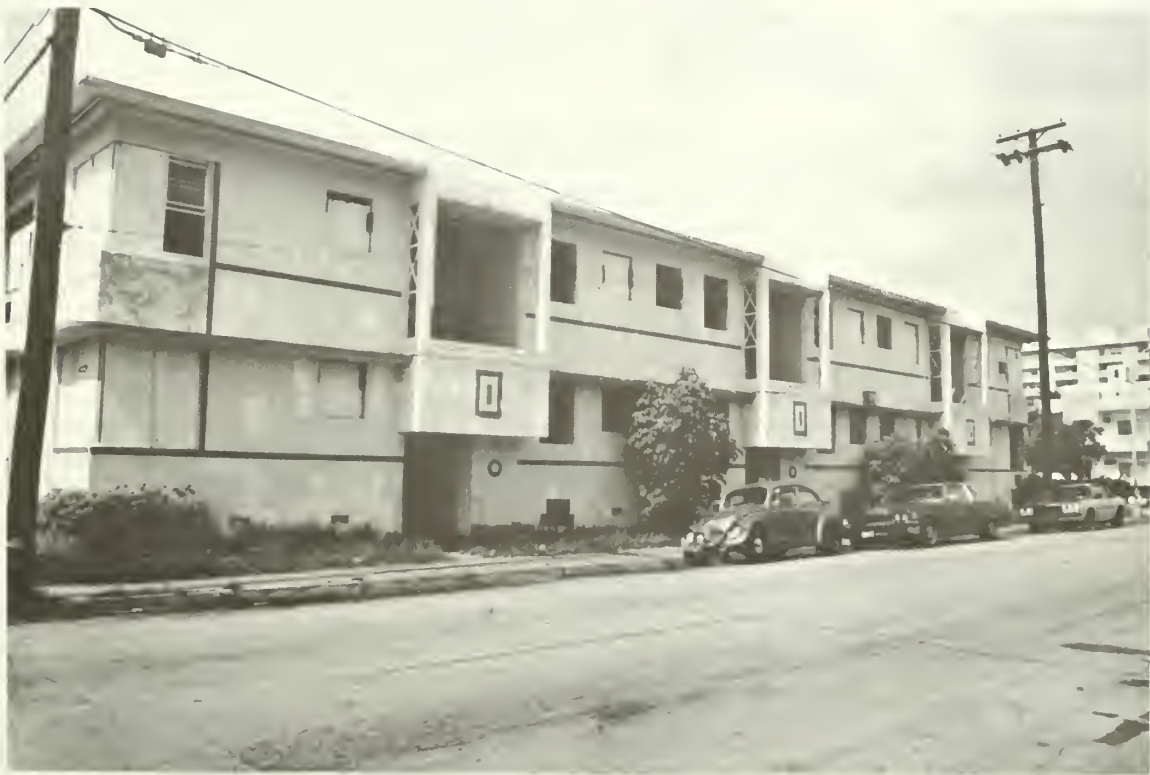
2. The street elevation of the building where patch repair work has already begun shows the decorative panels of local stone under the second story windows at either end of the building.

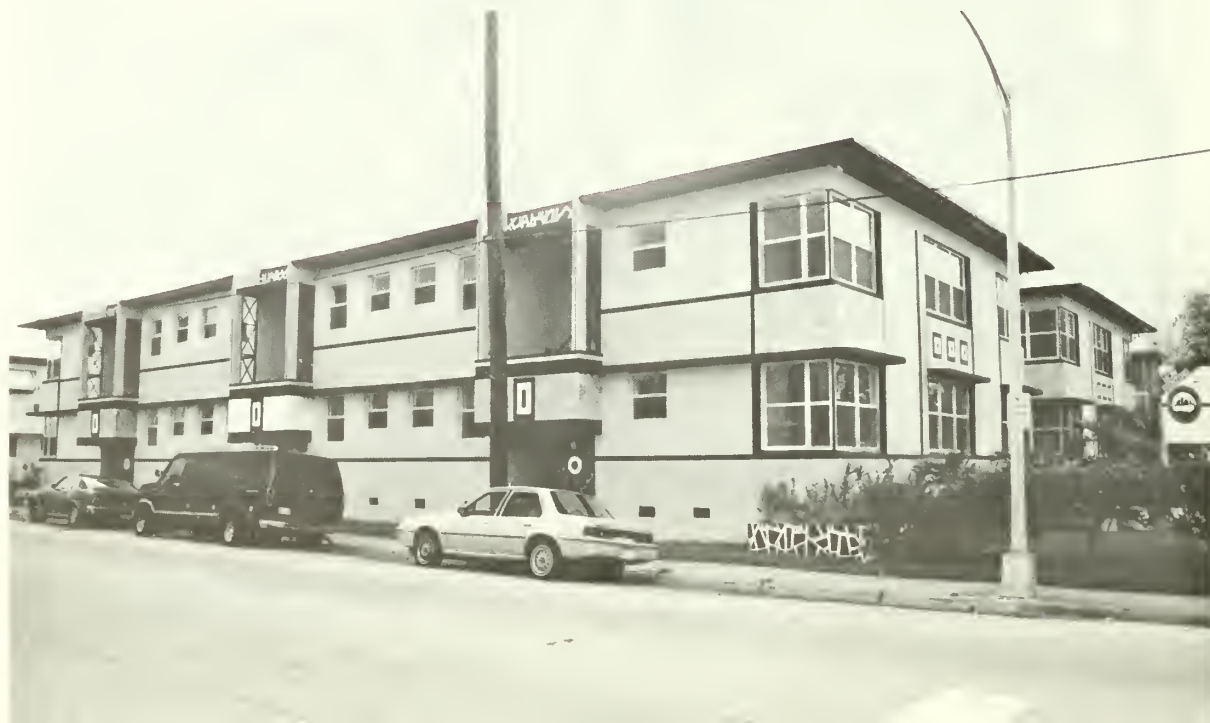
As part of the rehabilitation, the exterior stucco, which had been repaired and patched as necessary, was painted as the owner himself stated, in a "fanciful and sportive manner." Prior to rehabilitation, the building had been painted beige with a few of its decorative features highlighted in a darker brown. After rehabilitation, the wall surfaces of this building had been transformed by the application of numerous colors and decorative painted and patterned surfaces (see illus. 3-5). Wall surfaces were painted in alternating horizontal bands of aqua, yellow and pink, and projecting horizontal overhangs and the raised geometric panels were boldly outlined in black. Most notable was the use of paint to create contemporary stylized patterning, exaggerated illusionistic stone textures on door surrounds and above door panels, and a "cracked-tile" pattern above second-story stairwells and on planters surrounding the base of the building.

Consequently, as no evidence was presented to indicate that this type of exterior decorative painting had ever existed on this particular building, nor indeed on any building located in the historic district, it was determined that the decorative painted abstract patterns and faux finishes applied during the rehabilitation were inconsistent with the historic character of the building, and the historic district. The plain, unpatterned aqua, yellow, and pink colors on the walls were not considered objectionable, or in violation of the Standards, although it is most unlikely that they would have existed historically either in such a combination, or in such intense colors.

3-5. After rehabilitation the character of the building has been greatly changed by the application of a variety of decorative painted finishes, in particular the "faux" stone surfaces around doors, the contemporary patterned design used above doors and on balconies, and the "cracked tile" pattern on the planters that surround the building.

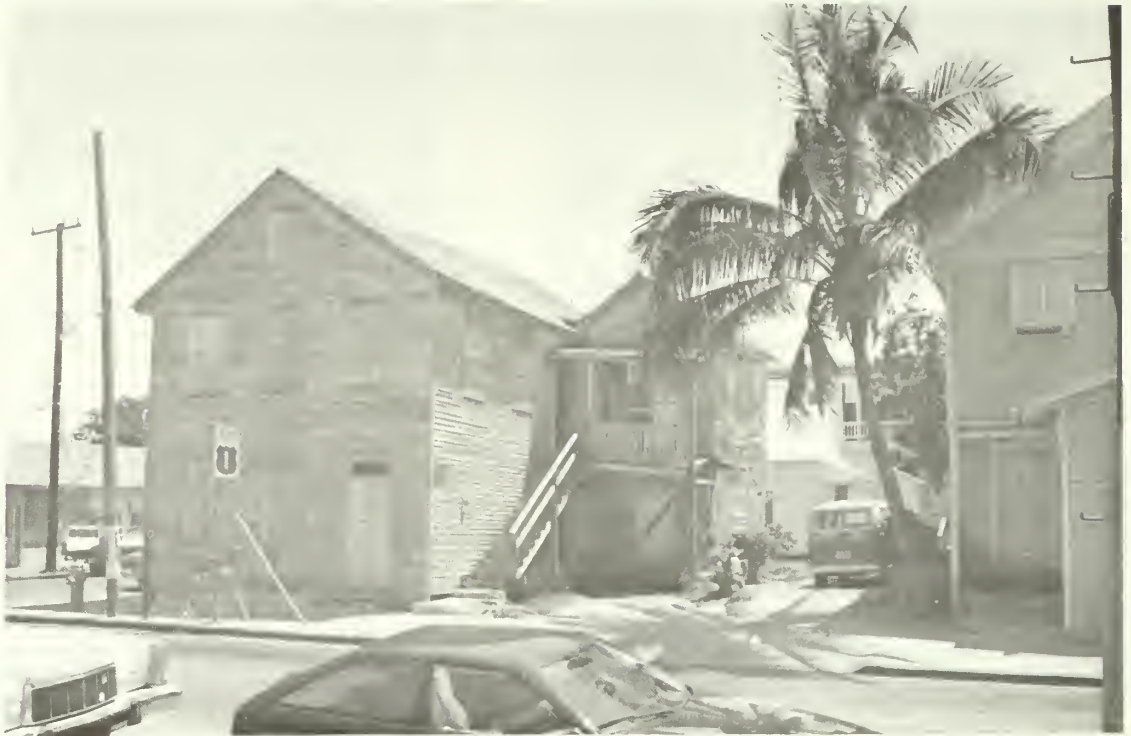
The existing staircase was constructed within the last fifteen years; no remnant of the original feature had survived to guide replication and photographic documentation was unavailable. In view of the Standard's cautions against reproductions which are purely conjectural, the owner maintained that any attempt to reconstruct a staircase would misrepresent the original type. Because the narrow width and deteriorated condition of the staircase made it undesirable to retain, the decision was made to remove the staircase entirely with no attempt at reconstruction.

1. This view shows the exterior staircase in place before rehabilitation. Although this staircase was a replacement of the original, the feature was significant because it had remained in the same location and because it announced a separate use and function for the second floor of the ell.

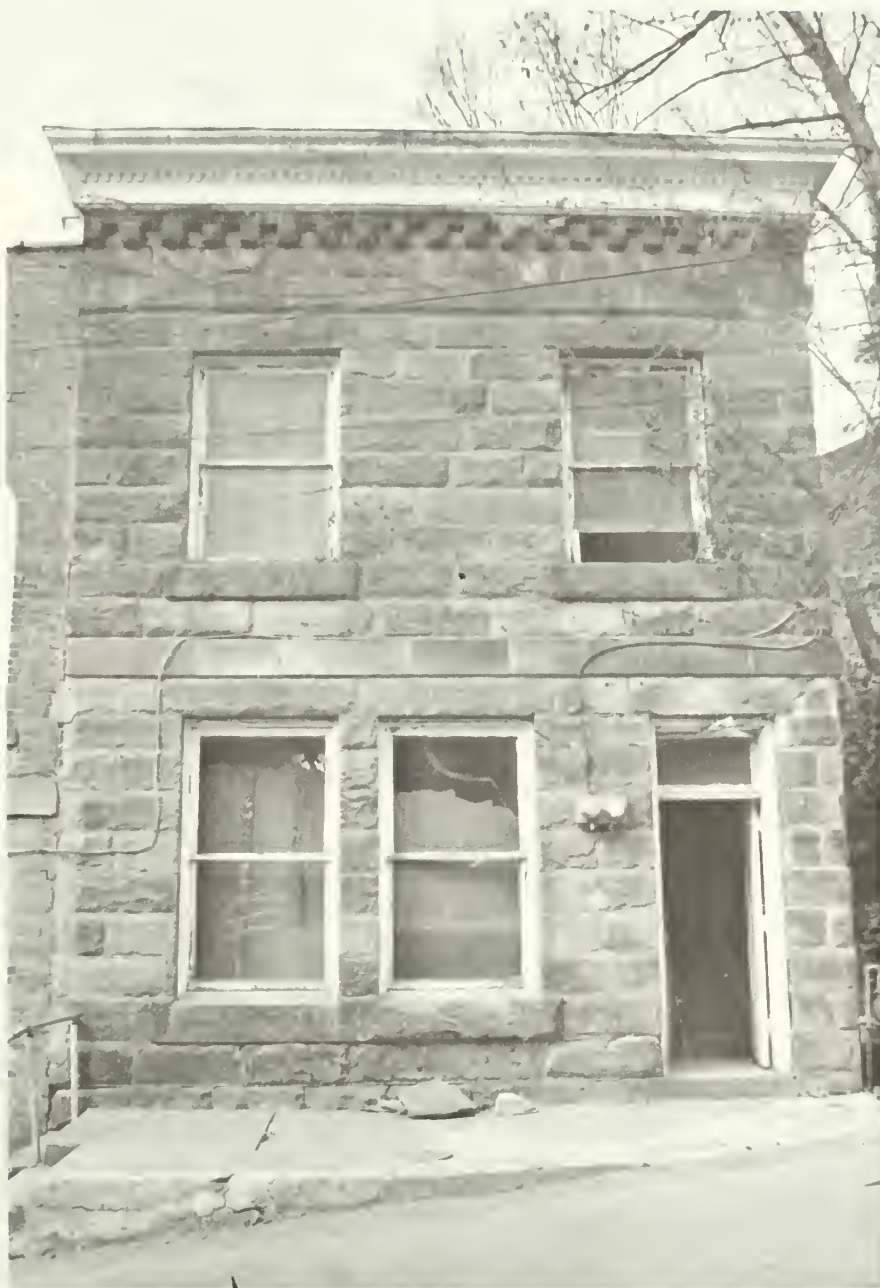
1. This small, semi-detached building was constructed in 1891 as a law office. A narrow walkway to the rear separates the building from the steep hill that abuts it on the right.

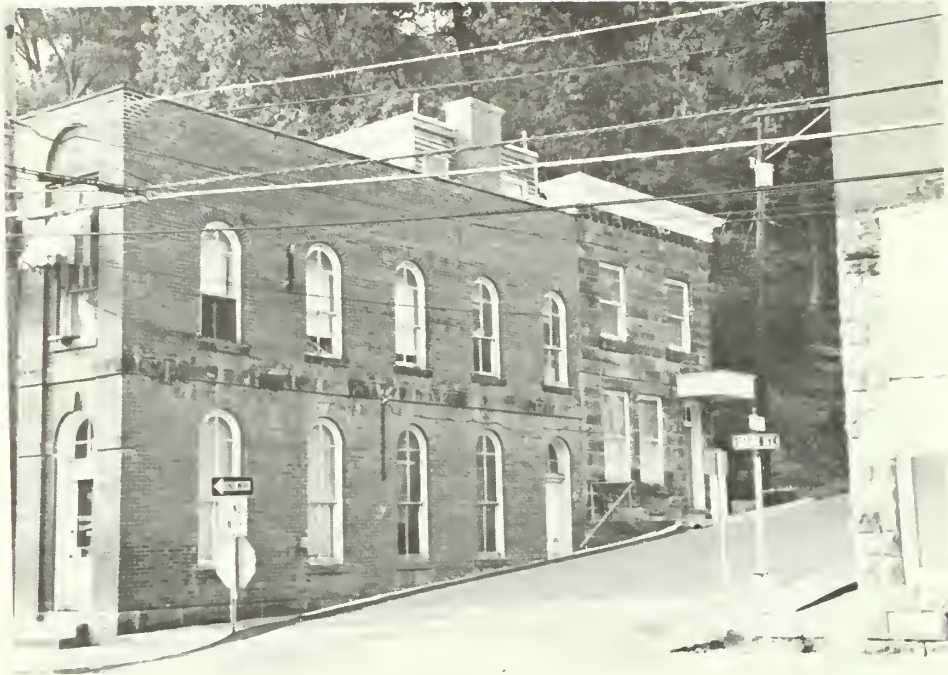
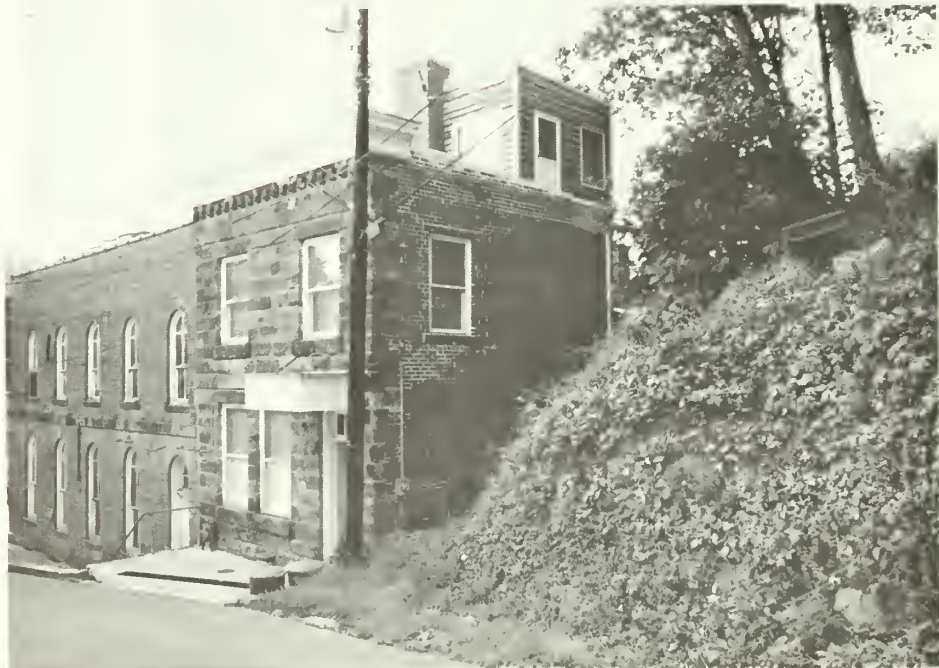
2-3. After rehabilitation, the new rooftop addition is highly visible within the historic district, both from below the building at the main intersection at the foot of the hill, and from above the building higher on the hillside.

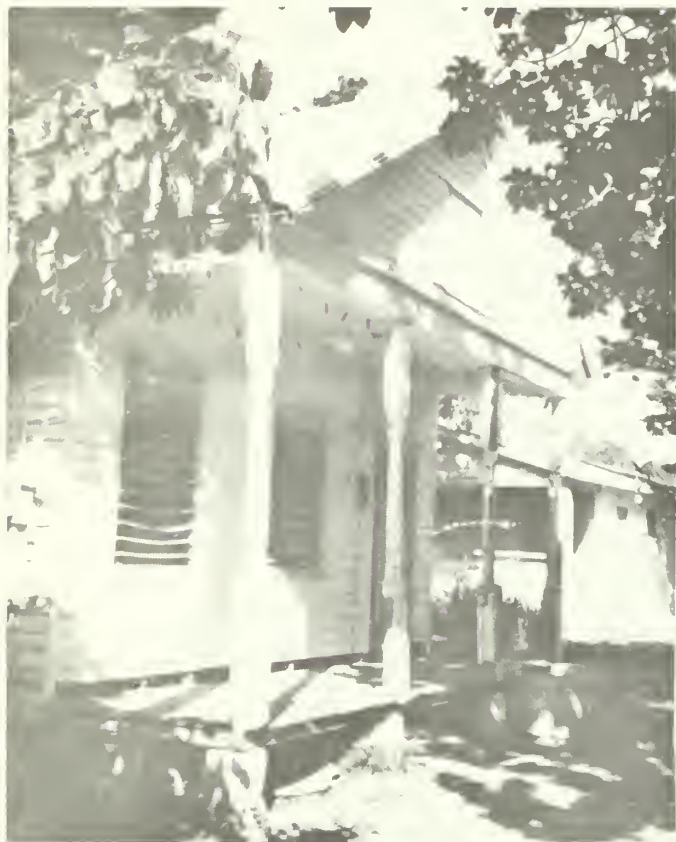
1. Simple turned posts and plain windows were the only expressive details of the vernacular frame building.

It is not advisable to impose a new stylistic identity onto a facade since attempts will most likely confuse the historic appearance of the building. Although an exterior of any size may lack elaborate detailing and texture, it is important to retain the simplicity which defines the building, realizing that historic character may be expressed only by the few modest details that exist. In this example, violation of the Interior's Standards occurred because the added decorative features caused the removal of historic materials and because the building was given an appearance conflicting with its historic one. By removing the added features and reinstalling the original posts, the visual appearance of the porch and windows can be readily retrieved.

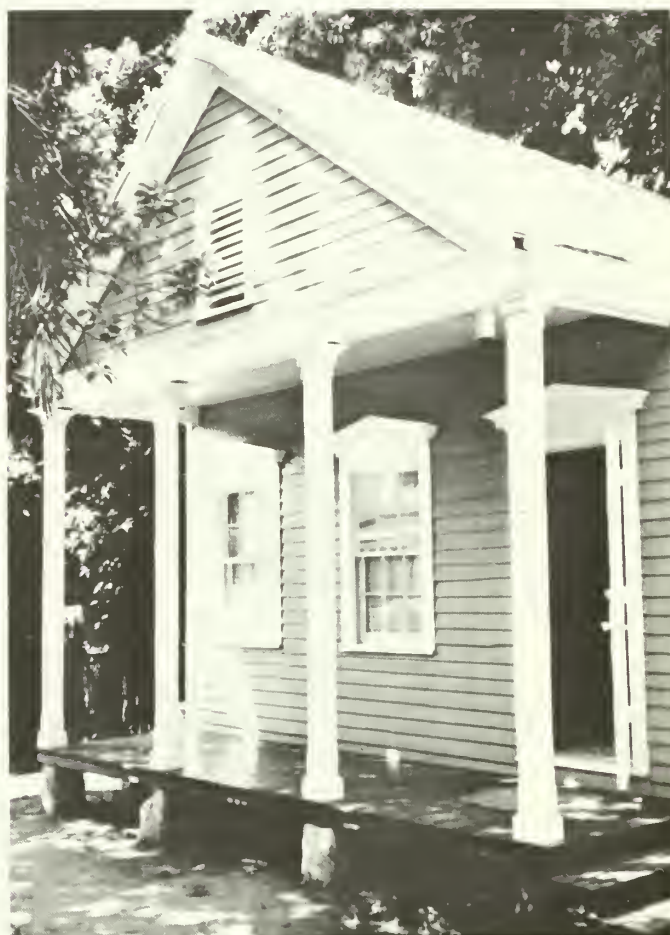
Application: In a historic district of vernacular wood frame dwellings, the main facade of a small, single story, simply detailed 1900 building was elaborated with details suggesting the Greek Revival style (see illus 1.) Triangular pediments were added to the window heads, and simple turned posts were replaced with square, Doric posts (see illus 2.) The resultant changes undermined the vernacular simplicity of the Victorian structure. Although buildings within the historic district built about the same time were fitted with Greek Revival details, they were without exception larger, more imposing structures. No other authentic examples of modest, similarly adorned structures could be found. However, even if such examples could be cited, the evidence would not prove that this building ever had these particular features.

The use of unprecedented details on this small facade is also historically and visually improper because the proportions of the new features create awkward junctures with the existing cornice. For example, the capitals of the posts are improperly scaled and project beyond the gable soffit (see illus 3.) The building's new presentation as a Greek temple is also unsuccessful due to the lack of entablature and requisite Classical cornices and moldings that would normally be found in the overlying gable of a true Greek Revival building.

2. The dramatic shift in appearance from a vernacular structure to a higher style building is achieved with Greek Revival posts and triangular window pediments. The building was not originally fitted with these details, nor is there any occurrence of these features on a facade of this size within the district.

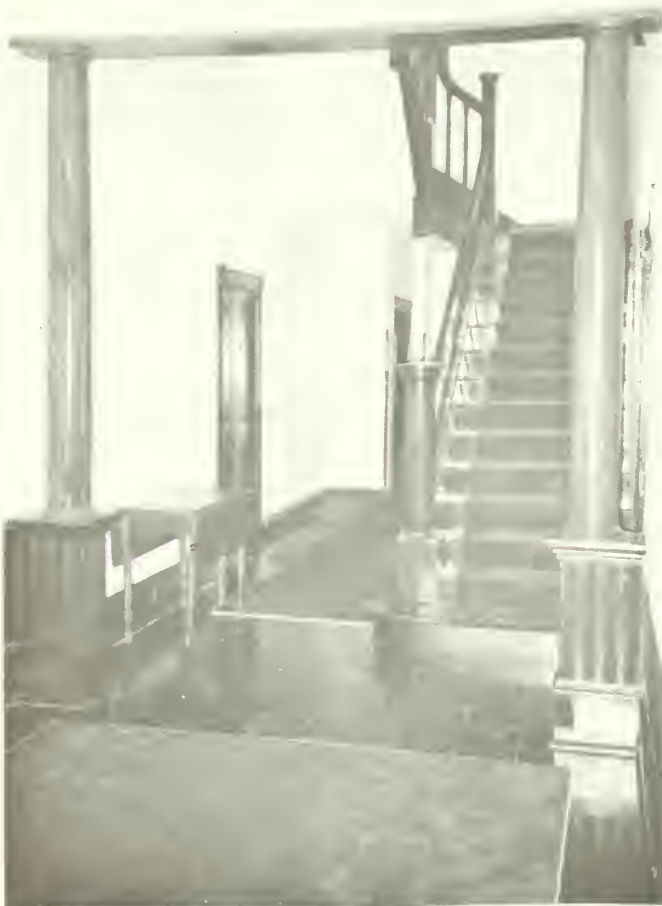
1. The only primary space on the first floor left unaffected after rehabilitation was the central hall, shown here with its original ceiling height and column divider.

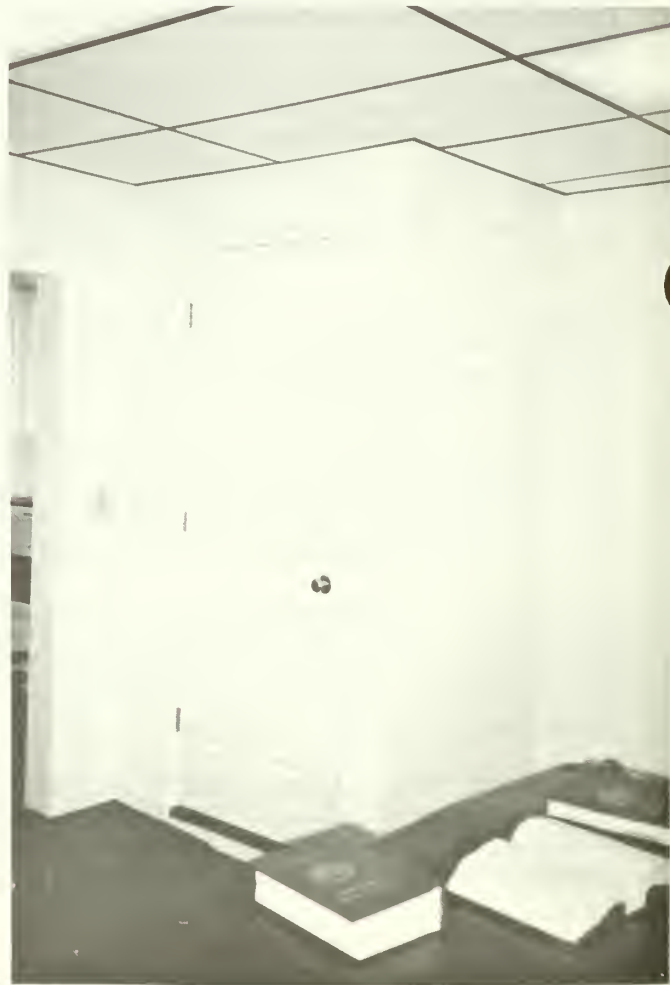
The project did not retain the architectural character and therefore failed to meet the Standards for Rehabilitation. In this particular case, there was no permanent damage to the historic materials, so the rehabilitation could potentially meet the Standards if the owner were to install a plasterboard ceiling more consistent with the original room proportions, preferably at the minimum required clearance for the HVAC system. One method to better integrate HVAC systems is the use of wall and ceiling chases. Failure to minimize the impact of the HVAC system and dropped ceiling may violate Standard 2.

2. This view shows the distracting metal grid and ceiling illumination of the new dropped ceiling.
